# Flight safety with el-gliders

Henrik Svensson

## Accident with UL-glider, Silent 2 during launch

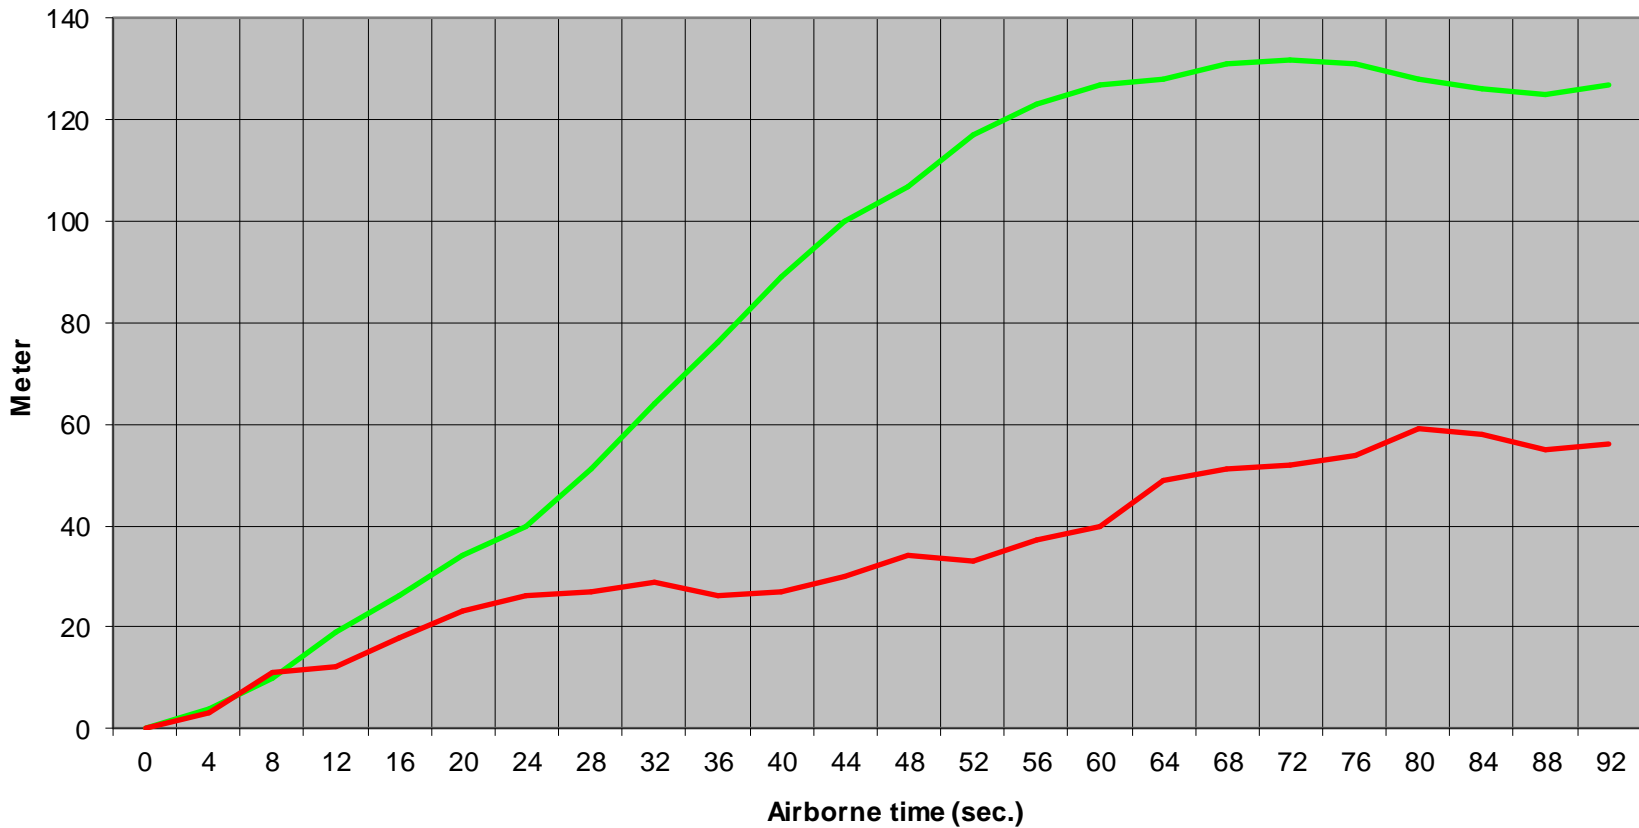
## Height

With this low power, the aircraft then climbed 0.6-0.7 m/s until the end of the log file.

The picture shows the climb profile at the current start (red) with reference to the start the day before (green).

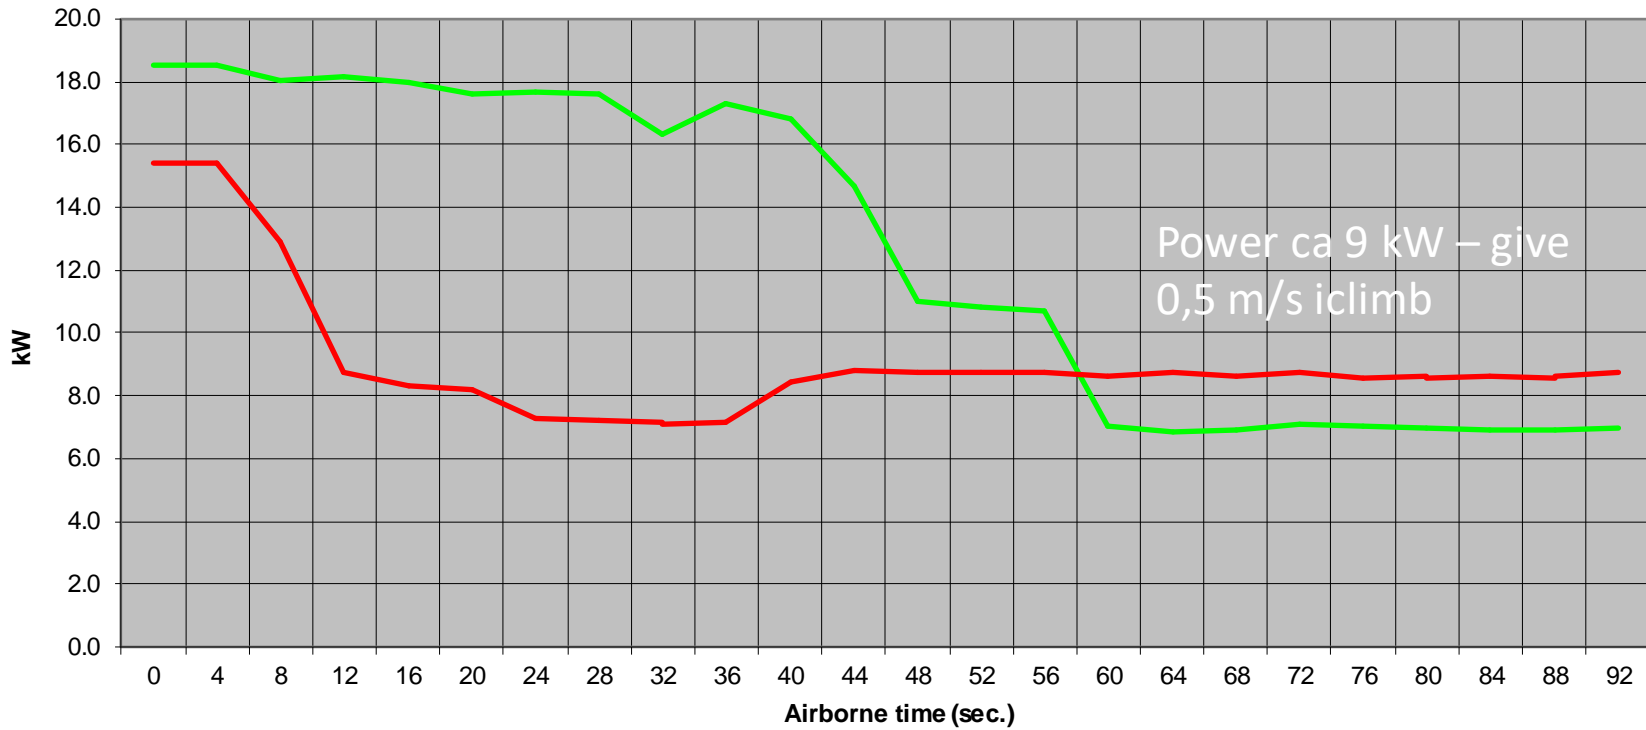
## Power

The voltage was 97V and with a current of 90A until the last log before the accident. This corresponds to only 9 kW (Max power is 22 kW). According to the manufacturer, the Silent 2 can barely climb by 0.5 m/s at this power setting.

The image shows engine power at the current start in red with reference to the start the day before.

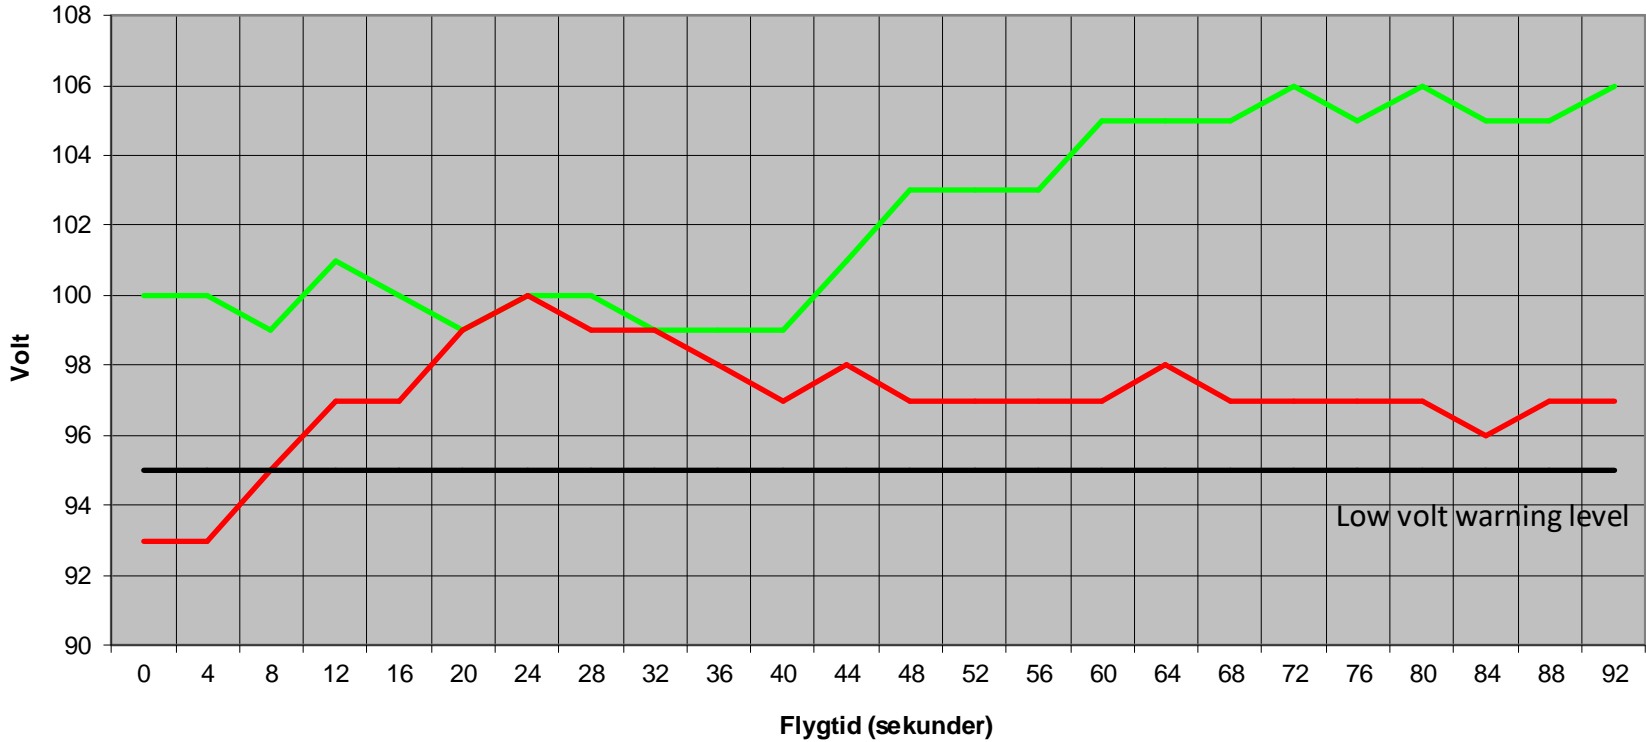
### Battery voltage

At the start, power setting was reduced immediately during the start. The display probably showed the text: "**Low voltage! Reduce power!**" already when rolling on the ground. The voltage was below 95 volts during the roll.

The image shows the battery voltage at the current start in red with reference to the start the day before.

When discharging a cold battery, the voltage drops rapidly at first but then stabilizes somewhat due to the internal heating of the battery.  
was higher.

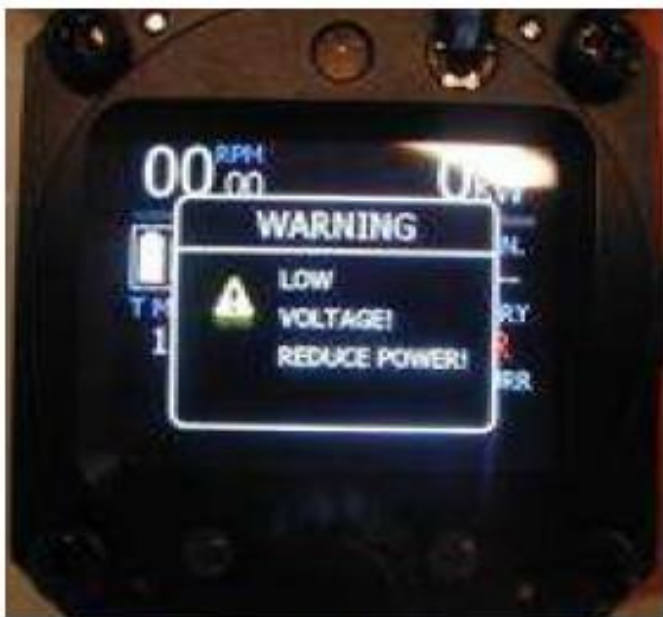
Fig. 9.6 – Example of warning message

Condition	Level	Message, action required
Voltage is low (95V)	Yellow	Low voltage, Reduce power

Condition	Level	Message, action required
Battery pack temperature is below 5°C	Yellow	Battery Low < 5°C, Do not self-launch!

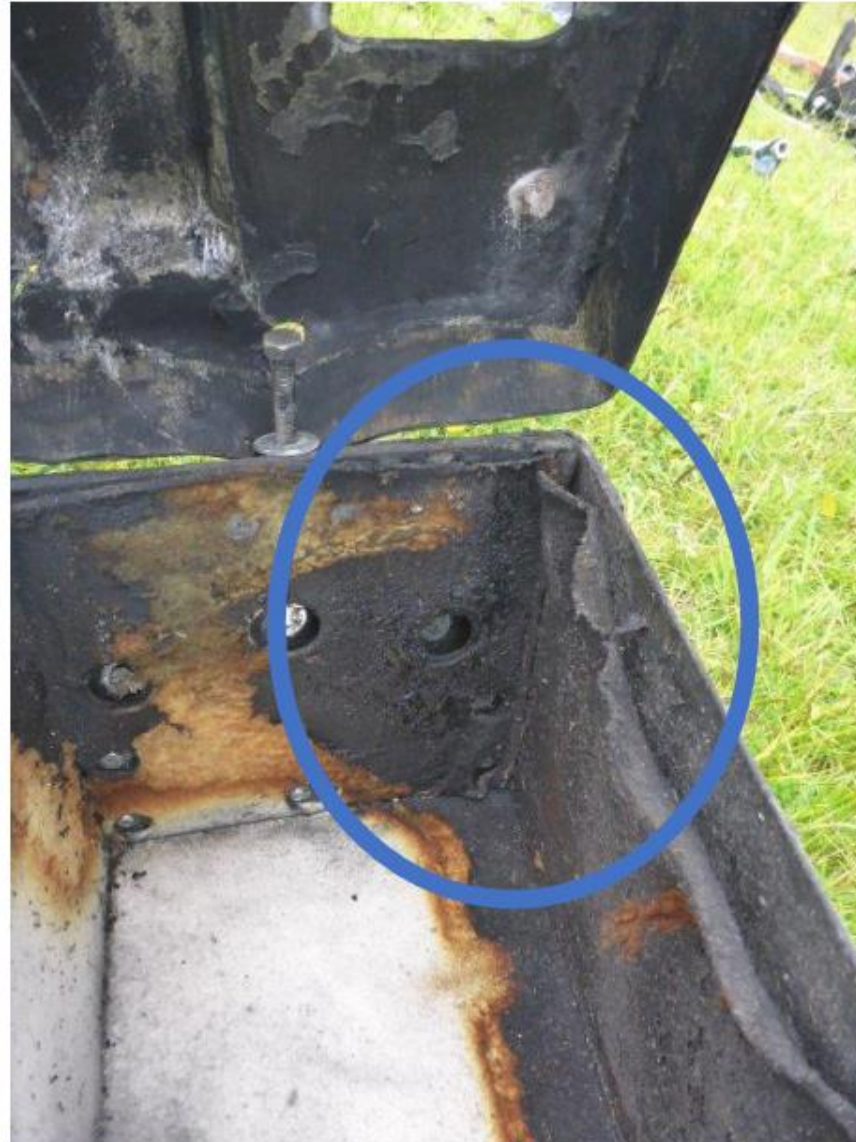
During the wreckage examination, evidence of an in-flight fire was identified. The fire appeared to have originated from, and was isolated to, the battery pack located behind the pilot's seat (see Figure 3).

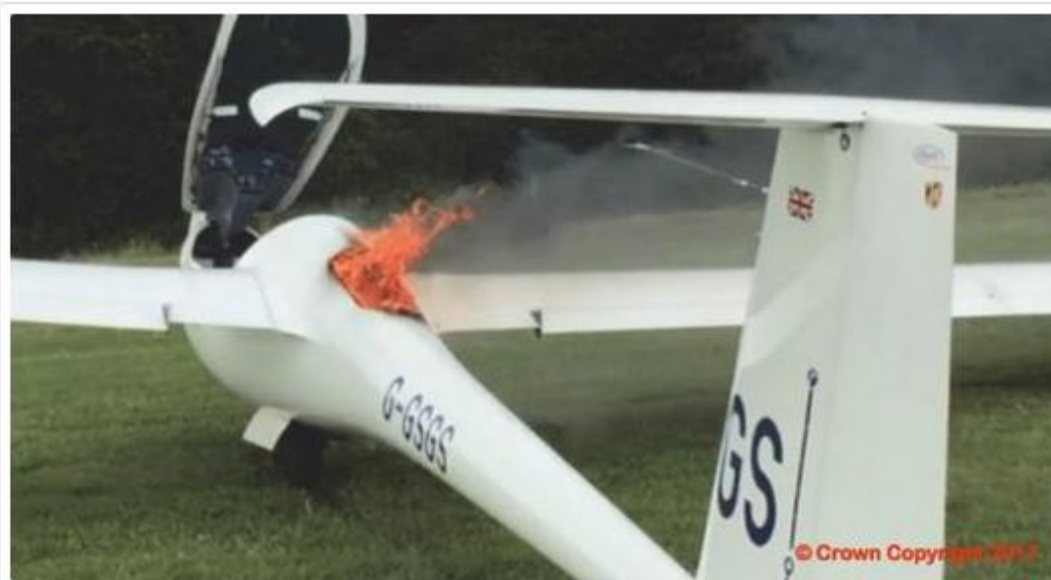
According to Klaus Burkard’s blog. “During the roll-out, the 55-year-old pilot smelled fire, while at the same time smoke was pouring into the cockpit from behind. The pilot was able to leave the aircraft uninjured after a [rolling to a] standstill.”

FIRE BLEW HATCH COVER OFF ON ROLLOUT. FLAMES WERE EXTINGUISHED BY FOAM-TYPE CHEMICAL

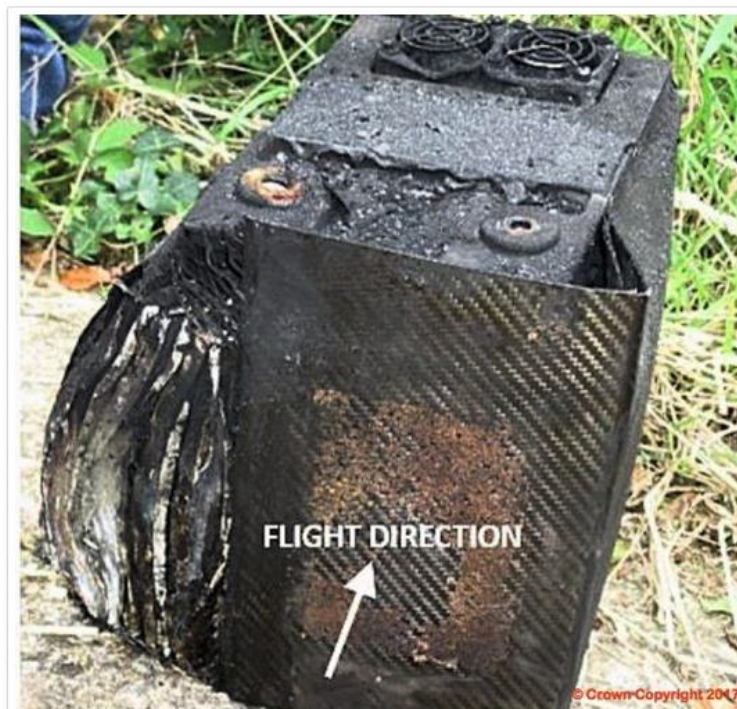
The pilot reported that in January, one of the battery boxes fell about 20 centimeters (eight inches) from his car to the ground. He apparently saw no damage to the case at that time. Because he did not mark or write down the ID for that battery pack, it was not possible after the fire to determine “whether the battery that had caught fire was the same one that had fallen out of the car before.”

DAMAGE TO FRONT BATTERY BOX ON BRITISH SAILPLANE. BOTH INCIDENTS WERE "LUCKY" IN OCCURRING AFTER A SAFE LANDING
