# Flight safety with el-gliders

Henrik Svensson

## Accident with UL-glider, Silent 2 during launch

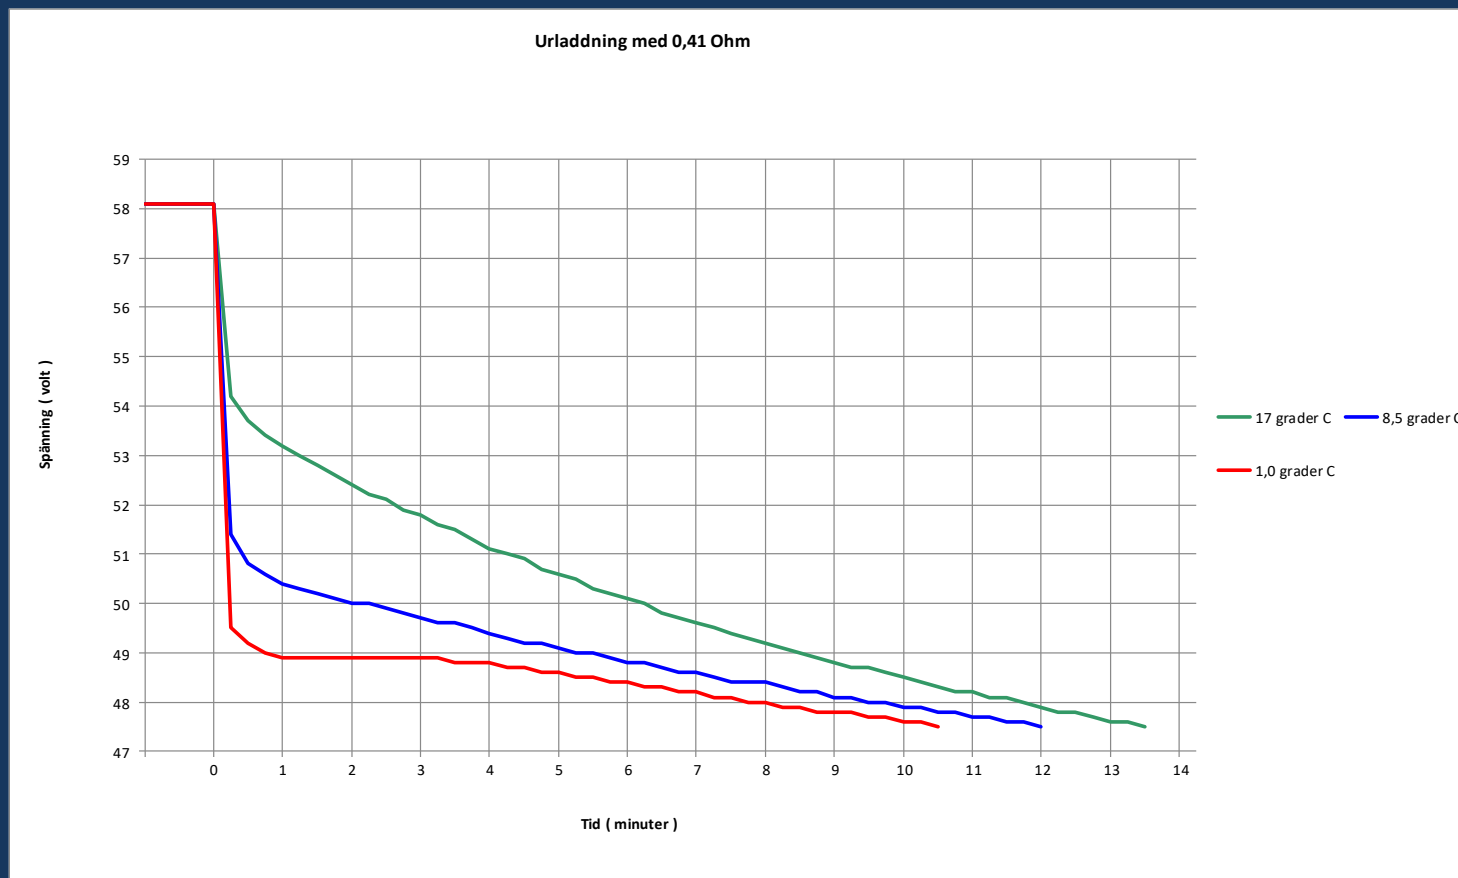
From Flight Manual:

## 9.1 Introduction

The electric powerplant installed in the Silent 2 Electro is intended for self-launching and shorter periods of powered flight for the purpose of sustaining soaring flight. The system is not intended, nor recommended for taxiing.

While the system is intended for self-launching, and is very effective for this purpose, self-launching places considerably higher loads on the system and in particular the batteries. For this reason, it is strongly recommended that self-launching only takes when the batteries are fully charged.

- Always self-launch with freshly charged batteries.
- Never self-launch when the battery temperature is very low. See temperature warnings for details.
- Always respond to any warning messages promptly – particularly those demanding that motor power be reduced or the motor stopped.

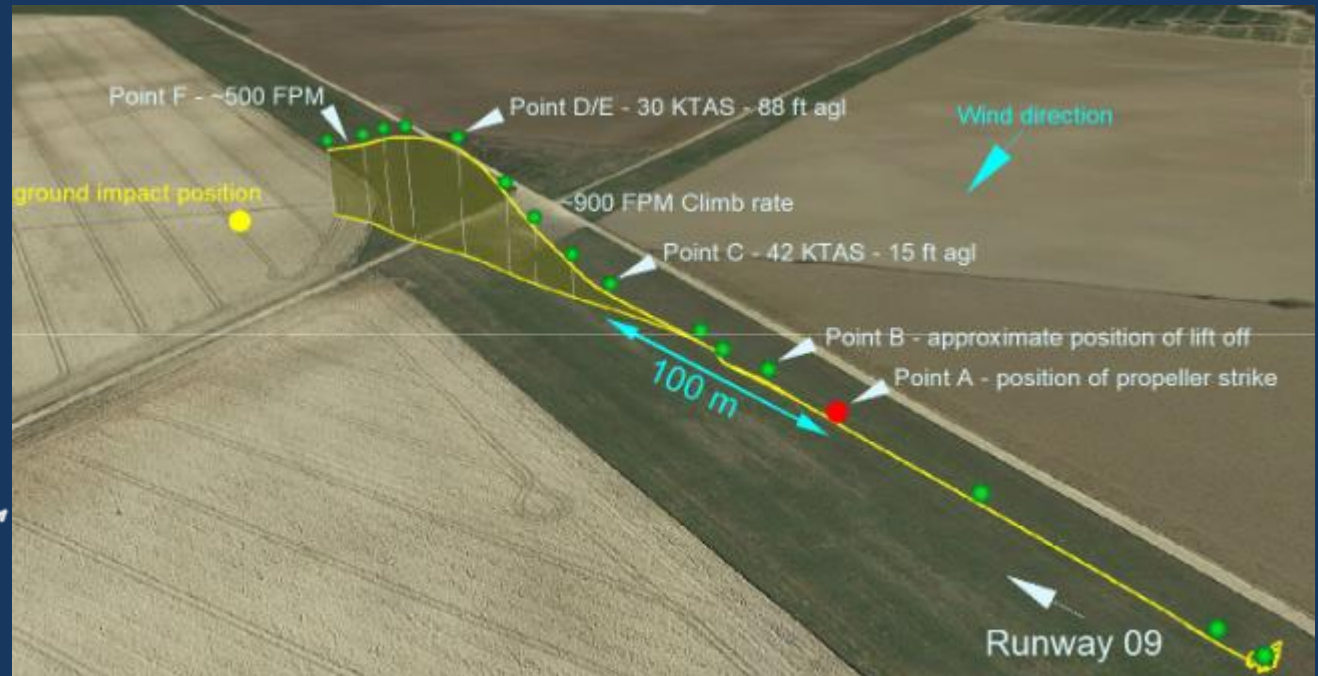
During the ground roll for a self-launched takeoff, the motor glider suffered a propeller strike shortly before it got airborne. The eyewitness evidence and recorded data showed that the glider climbed steeply to about 100 ft before stalling and entering an incipient spin to the left.

- While the FMM recommends pilots familiarise themselves with the stalling characteristics of the glider it does not specifically direct them to explore how those characteristics differ during powered flight.
- In a section called 'Electric Powerplant Use and Maintenance' the FMM states '*Always self-launch with freshly charged batteries*', but this does not appear in the 'Operating Limitations' section of the FMM.

While the glider was self-launch capable, the pilot generally preferred to winch launch to conserve battery power in case he ran out of natural lift while cross-country flying. Prior to 23 April 2021 (the day of the accident), *the pilot's previous self-launch was 8 months earlier*, and that had been his first self-launch since completing his initial training in January 2020

The pilot had not charged the FES batteries between launches on the day of the accident and reported being unaware the FMM *stated that self-launches should be carried out with fully charged batteries*.

The pilot observed that for an aborted takeoff, when compared with a standard cable release mechanism, the ergonomics of the FES control system were less intuitive. In an emergency requiring immediate motor shutdown, diverting attention away from flying the aircraft to locating and operating the FES throttle knob would be highly distracting at a critical stage of flight. Unlike pulling a cable release toggle, shutting down the FES was neither an instantaneous nor instinctive action. He considered that it would be safer if future designs for FES gliders incorporated a more intuitive and ergonomic means of cutting engine power.

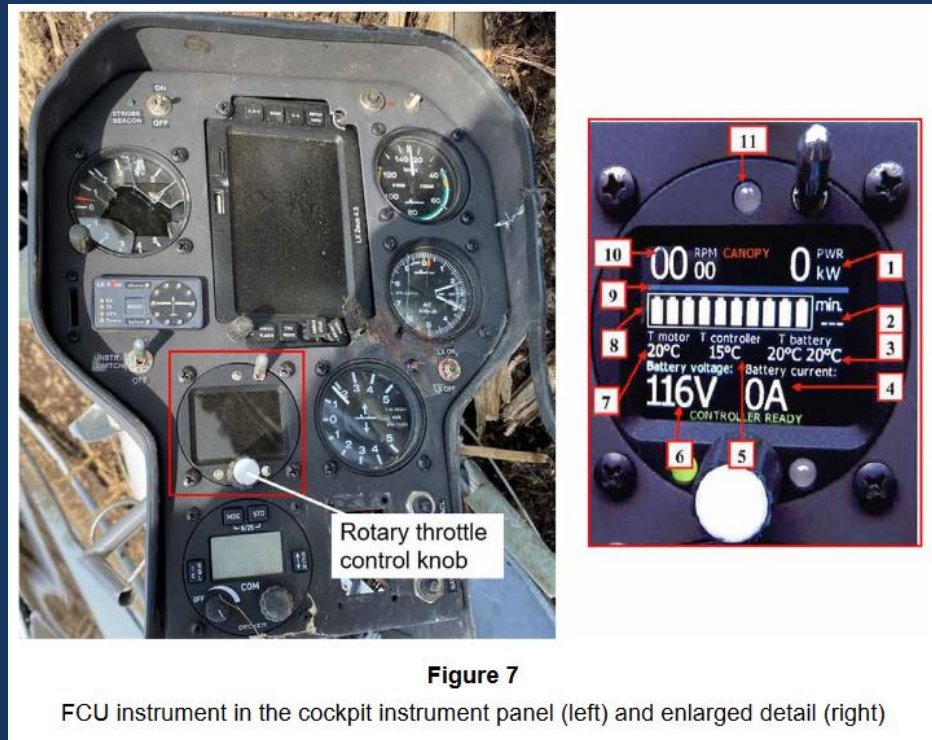
## BGA has published and sent a 'Safety Briefing' to Silent 2 Electro

### Guidance specific to the Silent 2 Electro

Test flying of a Silent 2 Electro in support of an accident investigation has identified several features associated with the type that pilots may not be aware of:

1. Very light stick forces in pitch combined with high levels of friction in the controls. This means the pilot receives minimal feedback on how the aircraft is responding to control inputs. Flying with a more forward cg should increase stability and stick forces.
2. Very little physical or aural indication that a stall is approaching with full power.  
*Practising power on stalls at a safe height can teach the pilot how to recognise*

7. Procedure for an aborted take-off. Cutting the power quickly using the FES rotary knob is not as easy or as intuitive as pulling back on a throttle lever (for example in a TMG). Pilots should on all occasions complete a comprehensive self-brief for the take-off and any eventualities. This should always contain a point on the take-off run where the acceleration of the aircraft can be checked. Pilots should mentally rehearse what they would do in the event of needing to abort a take-off to be able to correctly react to a problem.

5. The flight manual does not provide a take-off or climb speed. A climb speed of 50 kts provides normal handling and should ensure a good margin to stall

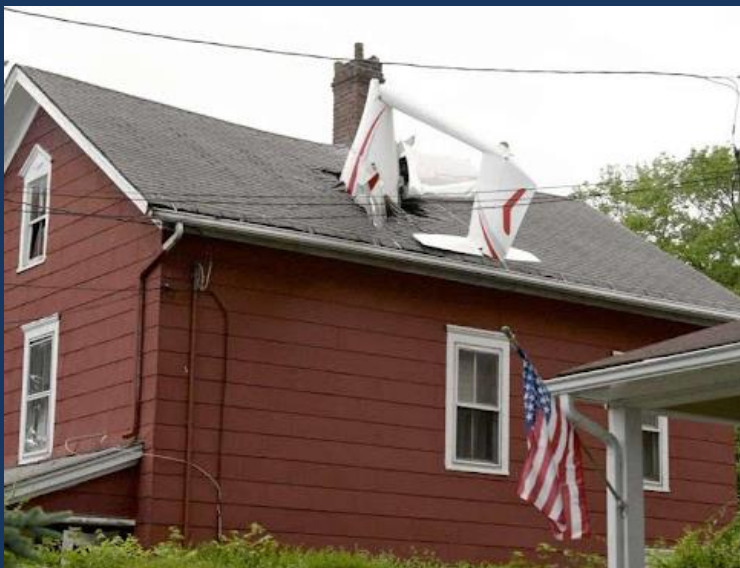
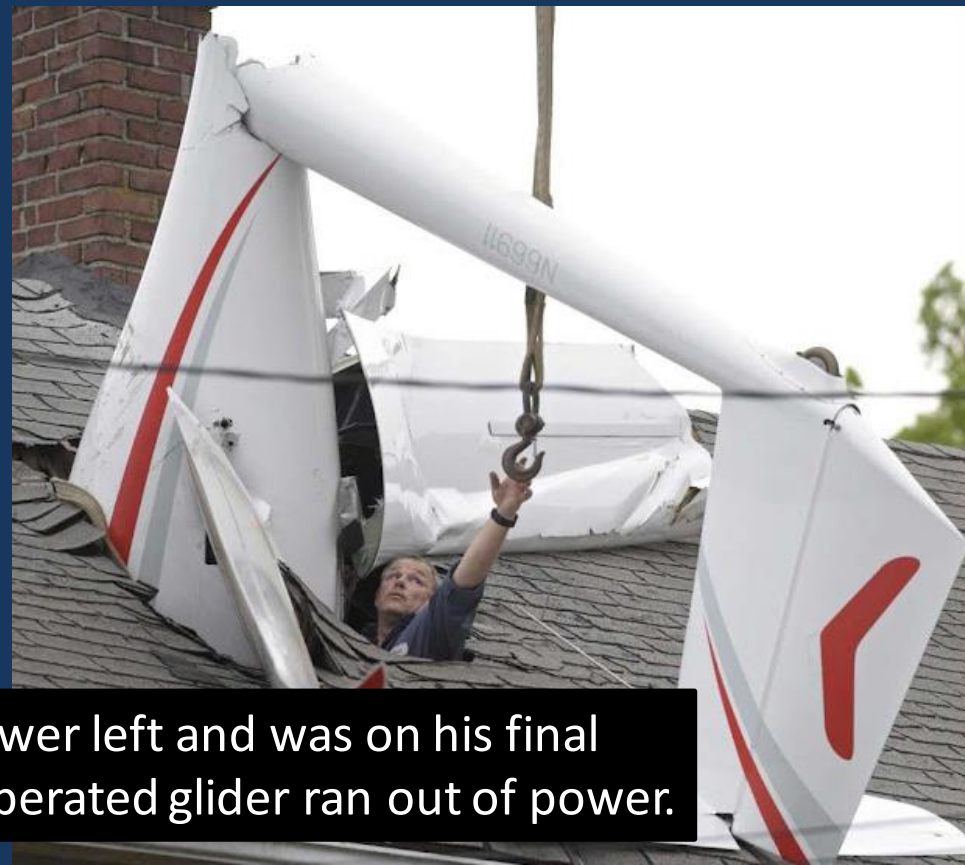
Alisport Silent 2 Electro, N66911: Accident occurred June 04, 2019 near Danbury Municipal Airport (KDXR), Fairfield County, Connecticut

Silent 2 Electro glider was substantially damaged when it impacted trees and a residence while on landing approach to Danbury Municipal Airport (DXR), Danbury, Connecticut. The sport pilot sustained minor injuries.

The pilot thought he had 20 minutes of power left and was on his final approach to the airport, but the battery-operated glider ran out of power.

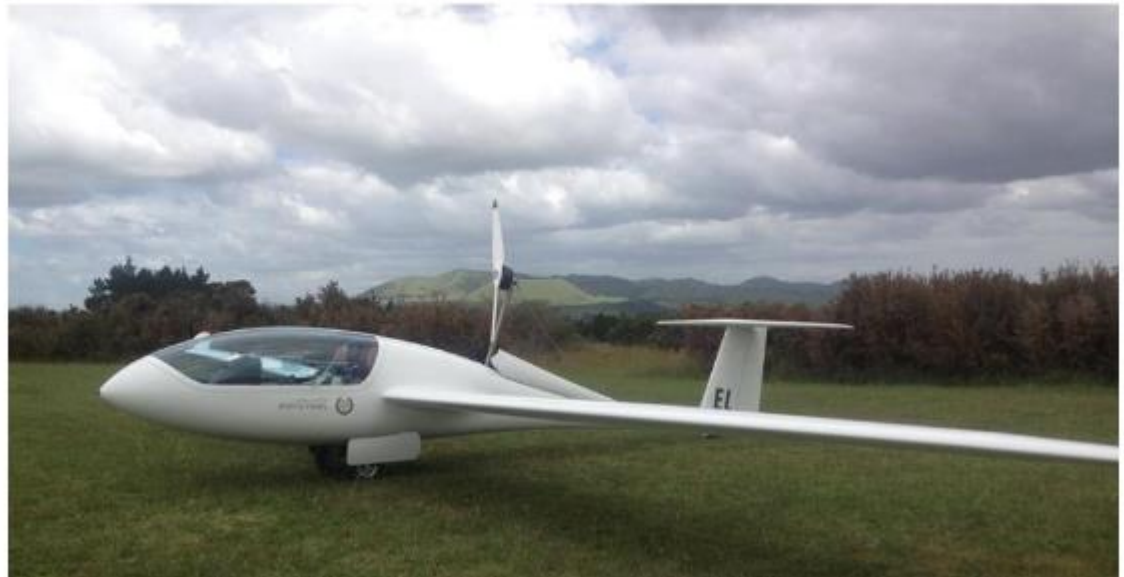
**KAIKOHE, NORTHLAND**

## Fire

- The battery packs had experienced some degree of impact, with the potential to compromise the battery structure.
- The batteries had not been charged in accordance with the manufacturer's recommendations.

- 3.1 During flight, one of the lithium polymer batteries fitted to the glider experienced a thermal event.
- 3.2 At the time of the in-flight battery thermal event, the glider had completed the take-off phase and was actively gliding with the motor retracted.
- 3.3 The pilot was presented with a challenging in-flight emergency.
- 3.4 It is likely that the pilot was attempting to return to the aerodrome to carry out an emergency landing.
- 3.5 The glider was in a high-speed descent, when the wings failed due to structural overload.
- 3.6 The accident was not survivable.

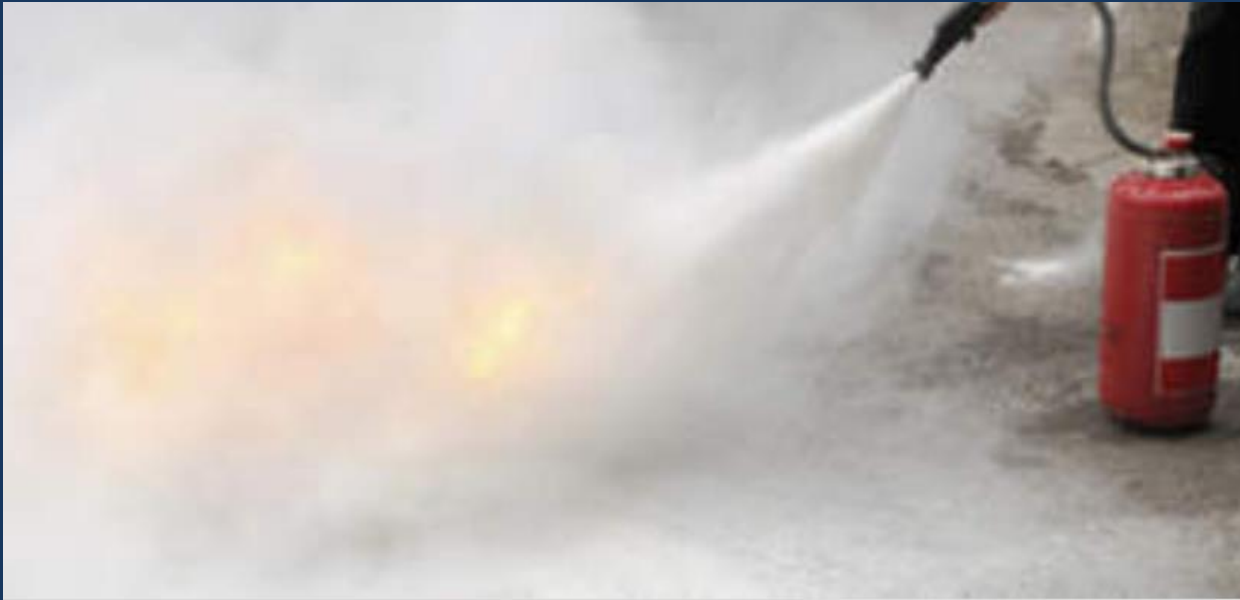
## Two Battery Fires in Self-Launching Sailplanes

Shortly after landing, an HPE glass-wing 304 eS/Shark FES sailplane “suffered a battery burn.” [The August 10, 2017](#) incident took place at Parham Airfield in Sussex, the UK.

The pilot reported that in January, one of the battery boxes fell about 20 centimeters (eight inches) from his car to the ground. He apparently saw no damage to the case at that time. Because he did not mark or write down the ID for that battery pack, it was not possible after the fire to determine “whether the battery that had caught fire was the same one that had fallen out of the car before.”

Klaus explains that for ultralight sailplanes powered by any electric power system, a battery fire in the air is a major problem. One can't jettison the batteries and popping the ballistic recovery parachute might cause it to ignite. The pilot's only hope, in that case, would be to leave the airplane and parachute to safety.

DAMAGE TO FRONT BATTERY BOX ON BRITISH SAILPLANE. BOTH INCIDENTS WERE "LUCKY" IN OCCURRING AFTER A SAFE LANDING
